# **PALMER PUBLIC LIBRARY ROOF COLLAPSE Structural Observation Report**

**February 28, 2023**

**PND Project Number: 231025**

**CITY OF PALMER**

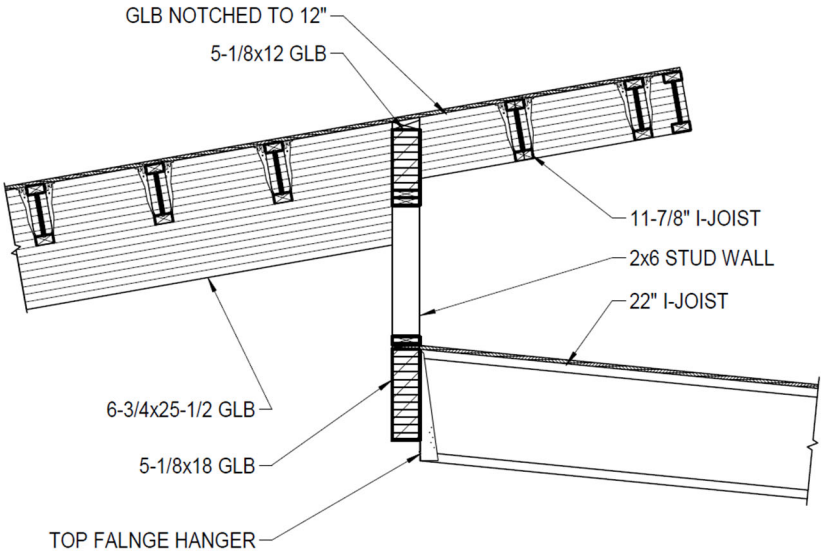
Figure 2: Roof Section before Collapse

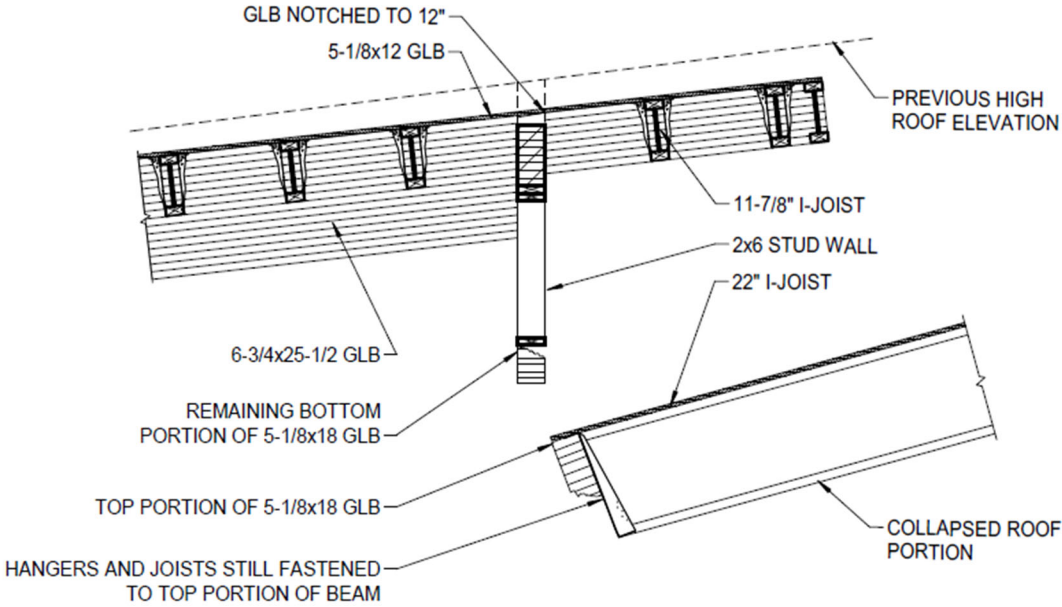
The top half to two thirds of the glulam beams had collapsed with the low roof and only the lower portion of the glu-lam beams remained on the steel support columns. The loss of the top portion of the lower glulam beam left the high roof members without support and they settled until they came to rest on the remaining portion of the broken glu-lam beam. **Figure 2** shows a sketch of the structural section as observed from the record drawings which shows how the low and high roofs were supported by the glulam beam prior to the failure. **Figure 3** shows the approximate post-collapse position of the remaining framing.

Figure 3: Roof Section After Collapse

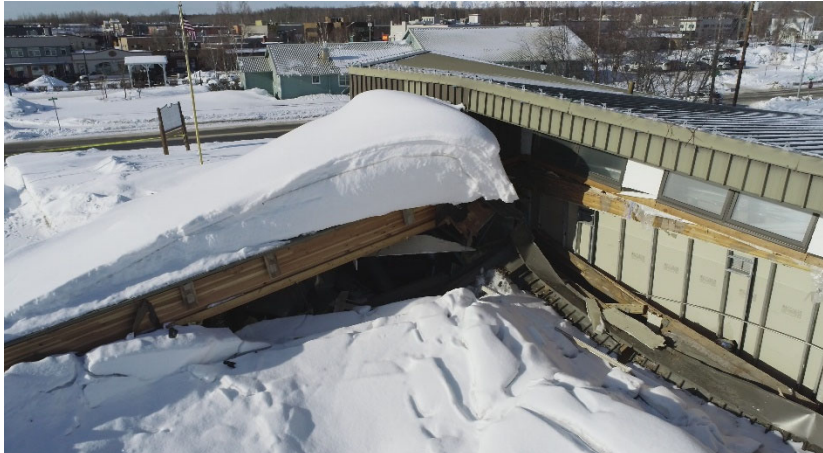
Photo 3: Roof Snow Drift

PND was able to observe the snow drift on the intact portion of the low roof (**Photo 3**). The snow extends from the low roof up to the underside of the high roof overhangs making the snow drift approximately 3 feet deep. The drift appeared to have a very dense lower layer that was topped by two or more layers of softer drifted snow. PND was unable to gain safe access to this drift to take a weight measurement.

PND strongly recommends that the remaining snow drift on the low roof be removed by a qualified contractor prior to the commencement of other work. The removal of these drift will help migrate the potential for additional roof collapse. PND recommends the use of manlifts and/or roof rakes during the snow removal to minimize the personal on the roof as much as possible.

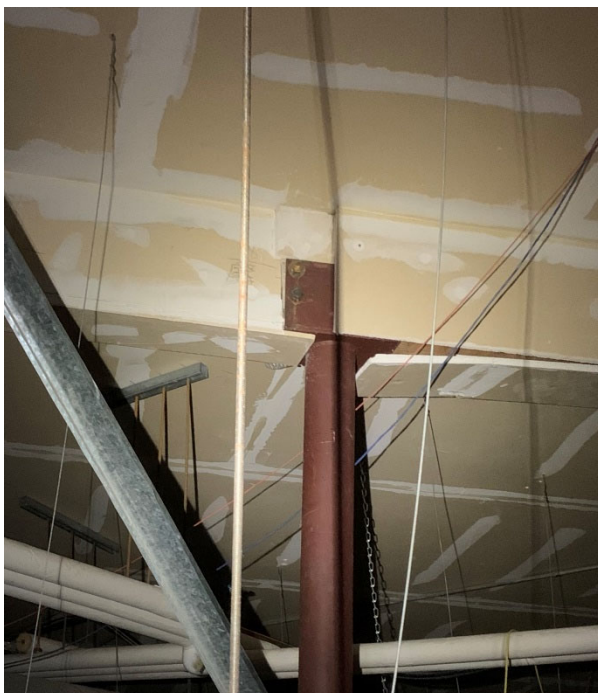
Photo 4: Beam Centered Over Column

The wood members above the ceiling grid were wrapped in gypsum wall board so a full observation of the members and their connections was not possible. However, PND was able to see that the beams were still centered over the interior columns and there was no evidence of large displacements of the roof beams along gridline 2 between grids C & D (**Photo 4**). PND recommends that the gypsum wall board in this area be removed to permit a full investigation of the area before other repairs are completed in the building. Based on the current limited review of this area, the beam and their connections appear to be intact.

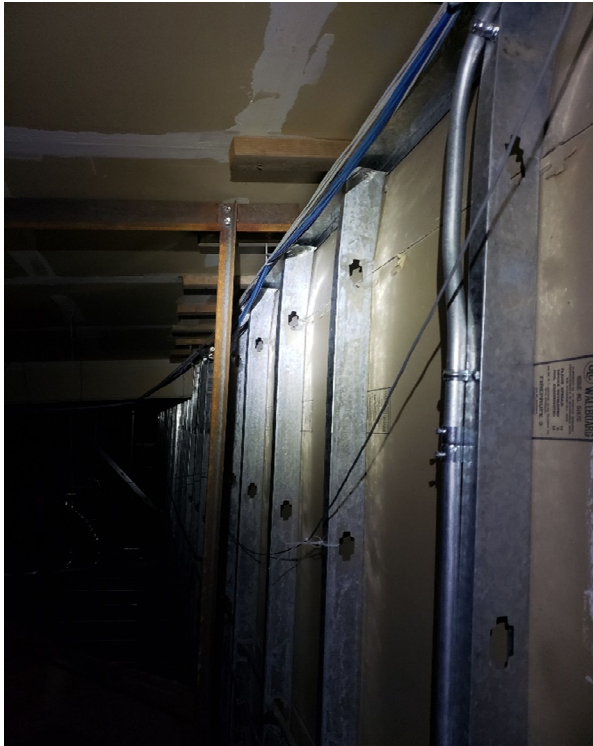
PND was able to observe damage to the backside of the soffit framing over the circulation desk area from above the ceiling grid (**Photo 5**). This damage is the result of the high roof beams losing support along grid line 3 and dropping and crushing the soffits below. Since the soffit framing was firmly attached to the walls and columns below, they could not move downward without being crushed by the high roof (**Photo 6**). Much of this soffit framing is not

Photo 5: Damaged Soffit

accessible for observation at this time. The soffit finishes should be removed in selected areas to allow for complete observation by an engineer before contractors begin clean up and repairs. This additional access will permit the engineer to determine the full extent of the damage and if the soffit needs to be removed to allow safe continued access to the area beneath it.

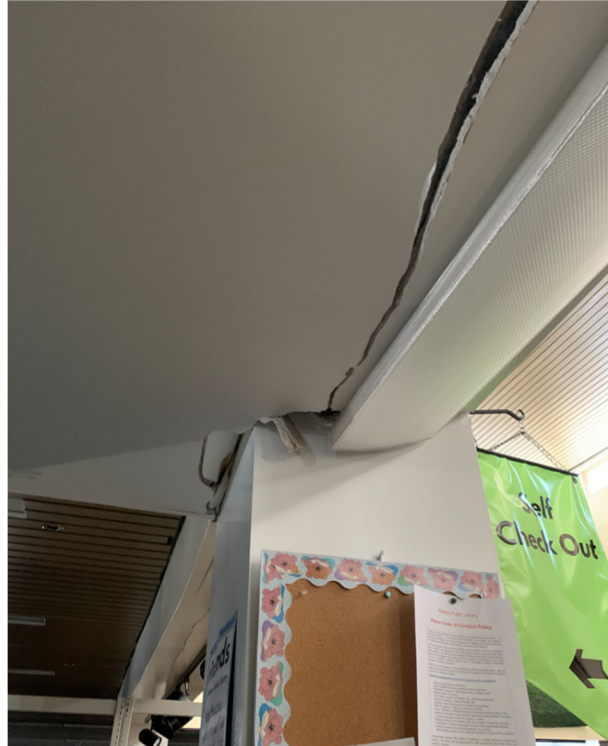
Photo 6: Crushed Soffit

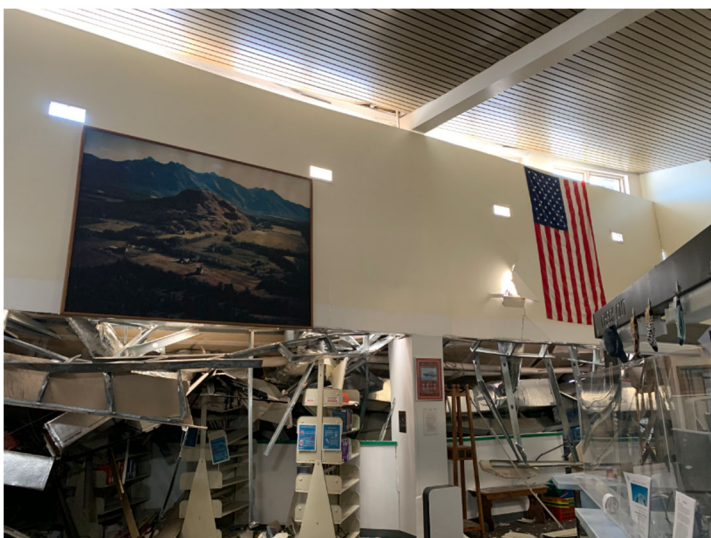
Photo 7: Collapsed Framing and Remaining Soffit

After assessing the high roof, PND shifted the focus to reviewing the area of low roof collapse. The low roof framing came to rest on top of the bookcases. Because the structure is still partially suspended, the collapsed framing is obscured by the remaining soffit that was framed below the roof before the collapse (**Photo 7**). PND was able to see that the top portions of the glulam beams, that broke away from the supports, were still attached to the low roof wood I-joists. The wood I-joists were still sitting within the light gauge steel top flange hangers (**Photo 8**). This observation meshes with the observations from the exterior of the building. PND was able to

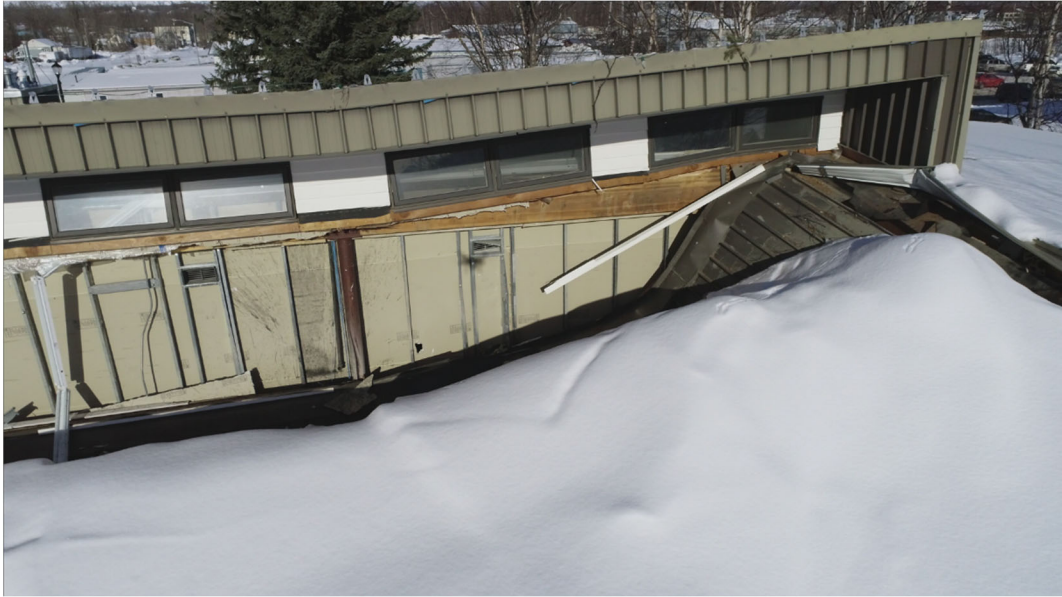
observe some water staining on the beams due to past water exposure but PND did not witness any areas of wood rot during the site visit. The complete condition of the round steel support columns and high roof beams could not be ascertained since the elements were still covered with finishes. At least one steel column appeared to be deformed as viewed from the from the drone footage (**Photo 9**).

Photo 9: Damaged Steel Column

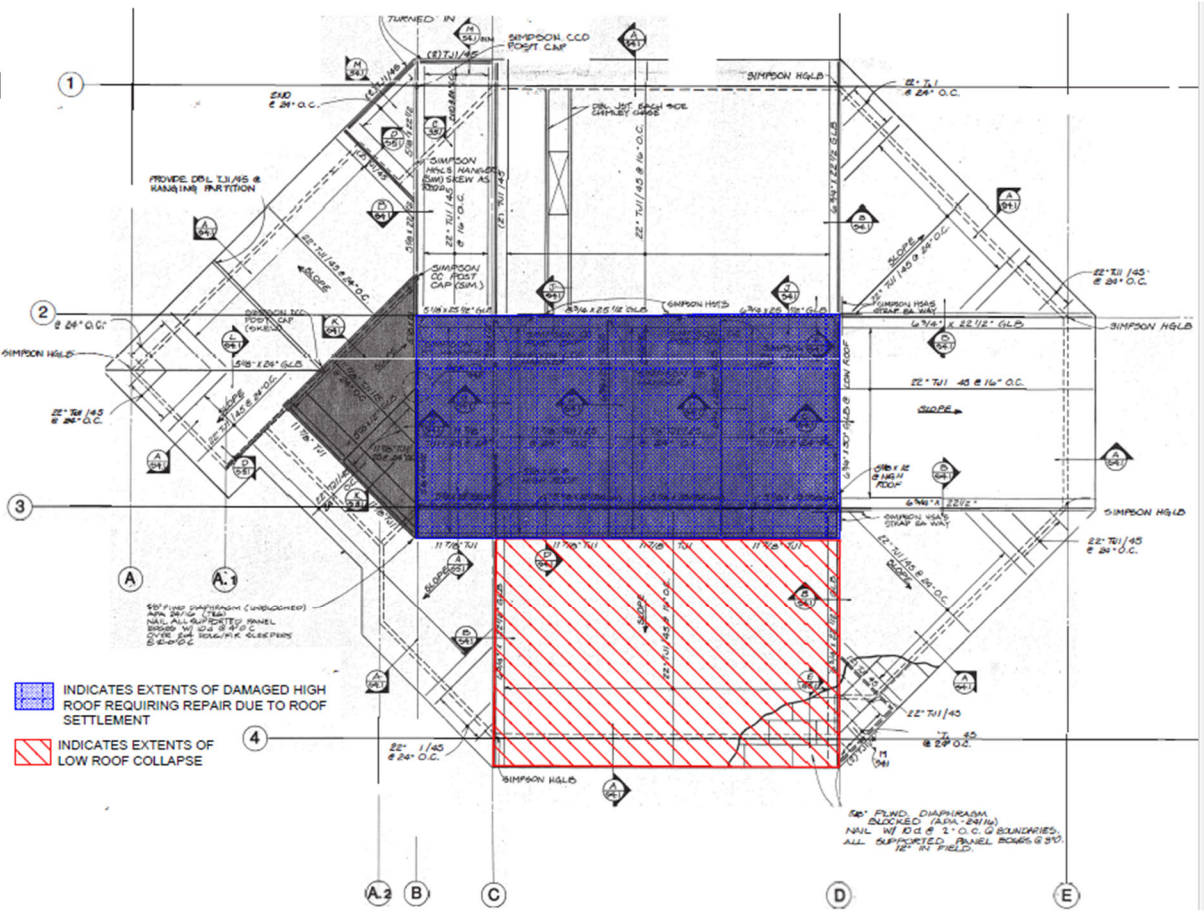
Figure 4 shows a roof plan from the building's record drawing with a summary of the damage observed during PND's site visit. This figure only identifies the areas of known damage. It is likely that additional damage will be discovered as building finishes are removed.

Figure 4: Summary of Observed Damage

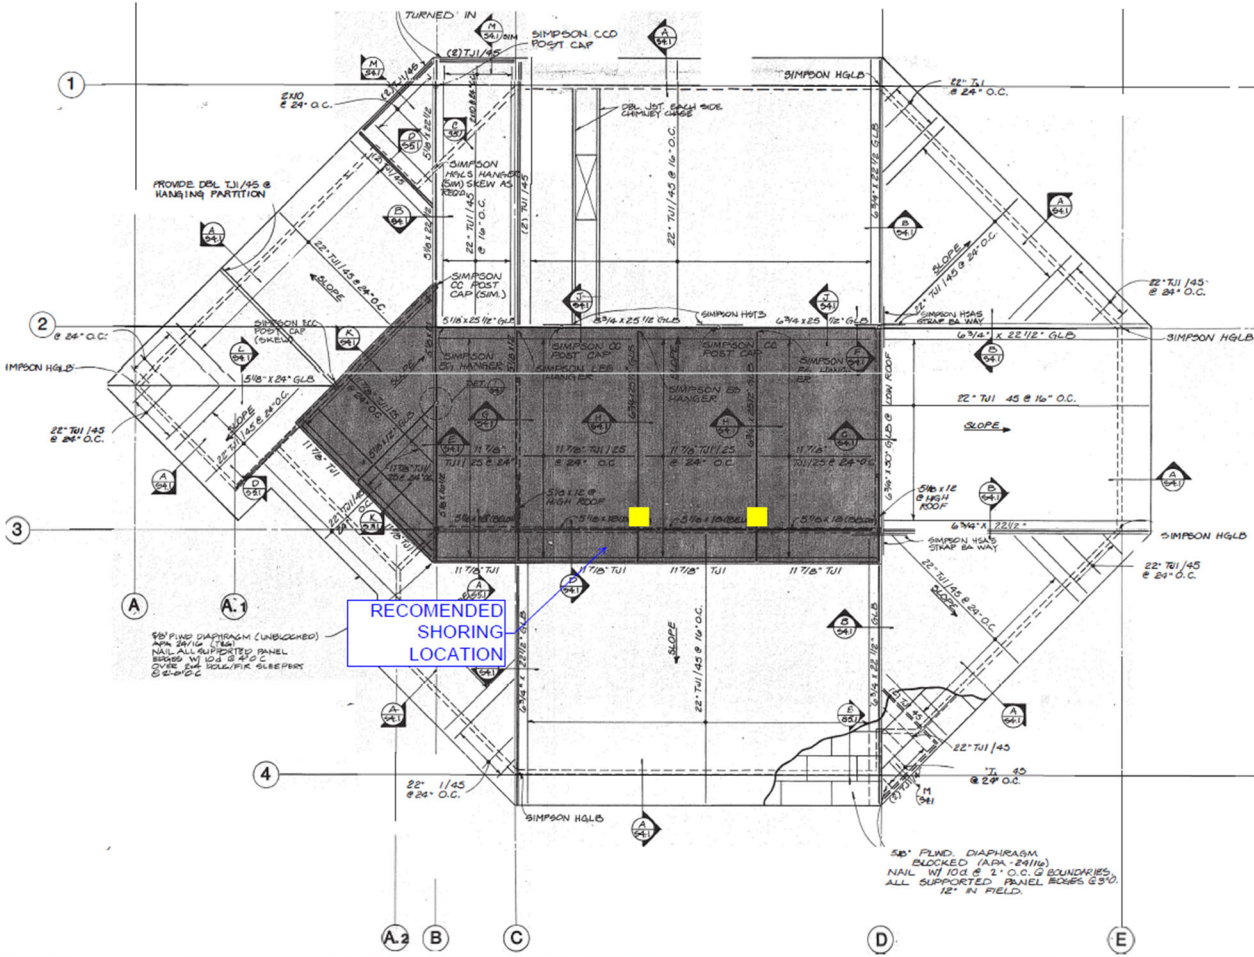
Figure 6: Approximate Shoring Locations

The failure of the lower roof glu-lam beams has left the high roof unsupported. PND strongly recommends that the high roof glu-lam beams be shored to provide support from the roof to the ground level before any recovery or repair efforts are conducted within the structure. Each high roof beam should be shored with either an 8x8 Douglas-Fir #1 timber post, a steel HSS4x4x5/16 column, or a steel shoring jack rated for 25,000 pounds. These posts shall be positively attached to the roof glu-lam beams and concrete slab to prevent movement during repairs. **Figure 6** shows the approximate locations of the recommended shoring posts. Once these shoring posts are in place, a contractor may begin to open up the damaged walls and soffits to allow a full observation of the structure. Once the full extent of the damage has been determined, the plans for cleanup and recovery of the structure may begin.
