# Palmer Public Library Conditions Survey

# **PALMER PUBLIC LIBRARY ROOF COLLAPSE Structural Observation Report**

**February 28, 2023**

**PND Project Number: 231025**

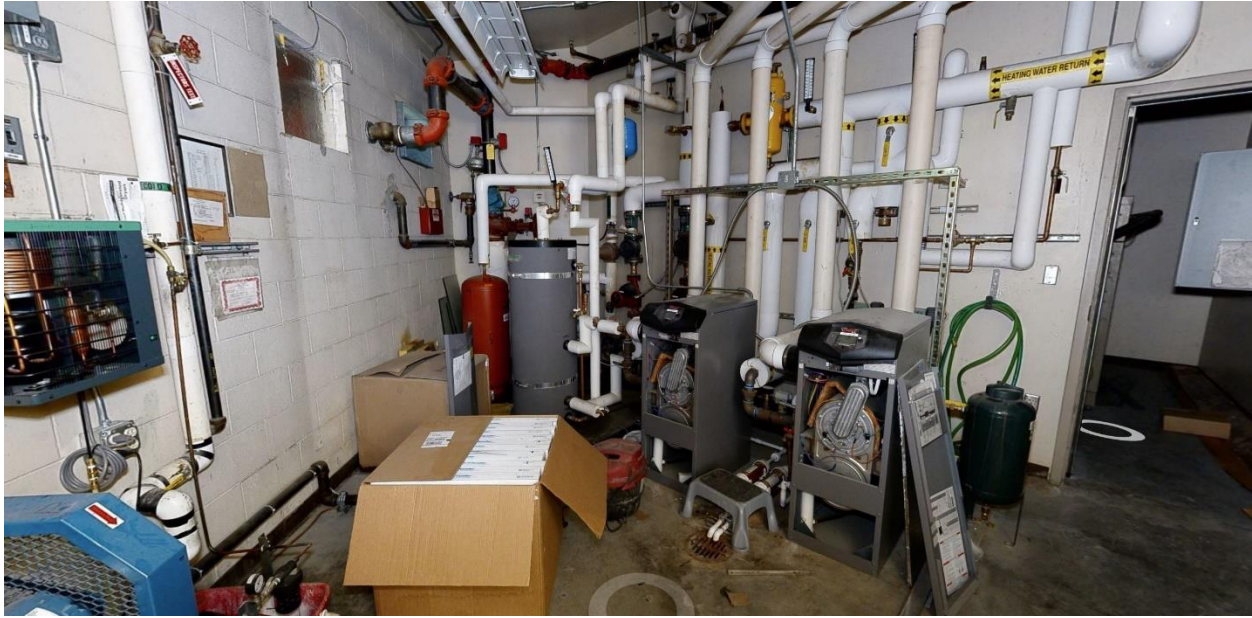
*Mechanical Room*

The plumbing system in the building consists of copper piping for the domestic water supply, cast iron waste and vent piping. Within the boiler room where the city water service is located, there are signs of pipe bursts. A complete inspection with pressure testing of the domestic water piping system would be required to verify the extent of piping damage.

The heating system consists of two Lochinvar KBN400 boilers that are within 5 years of age. They appear to be in good condition, an actual startup will verify actual performance. The heating piping serving the building is comprised of copper piping supply heating medium. The system does not have a glycol tank or means of injecting glycol, indicating that water was the usable medium for heating. The expansion tank on the boiler loop has burst from the freeze up, further pressure testing of the piping system needs to occur to verify the integrity of the piping system. The hydronic piping serving the area of the roof collapse has been destroyed beyond use.

It is recommended that the entire mechanical system be replaced as part of any renovation/reconstruction.

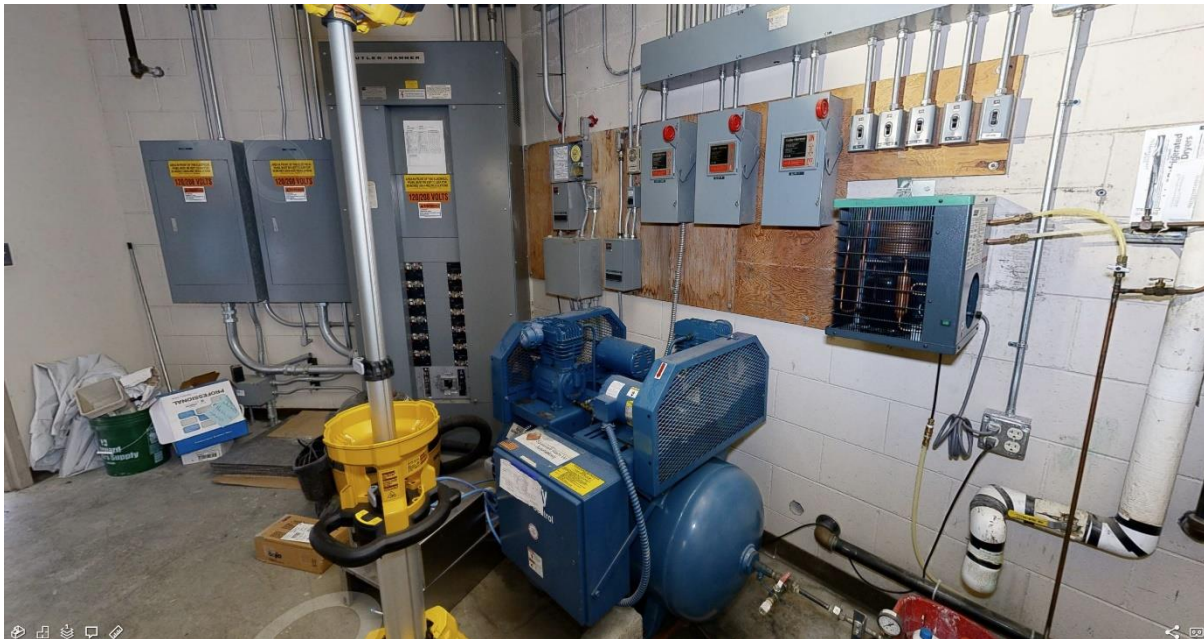
*Electrical Service*

3. The electric service is rated at 800 amps, 208 volts, 3 phase. Both the main disconnect and the metering enclosure are located indoors. The existing 800-amp electric service would likely be adequate to serve a new building of the same size. Increasing the building size would likely require increasing the electric service size. Current utility company standards require both the main disconnect and the CT enclosure to be located outside, so all three proposed projects would require a new electric service.

It is recommended that the entire electrical system be replaced as part of any renovation/reconstruction.

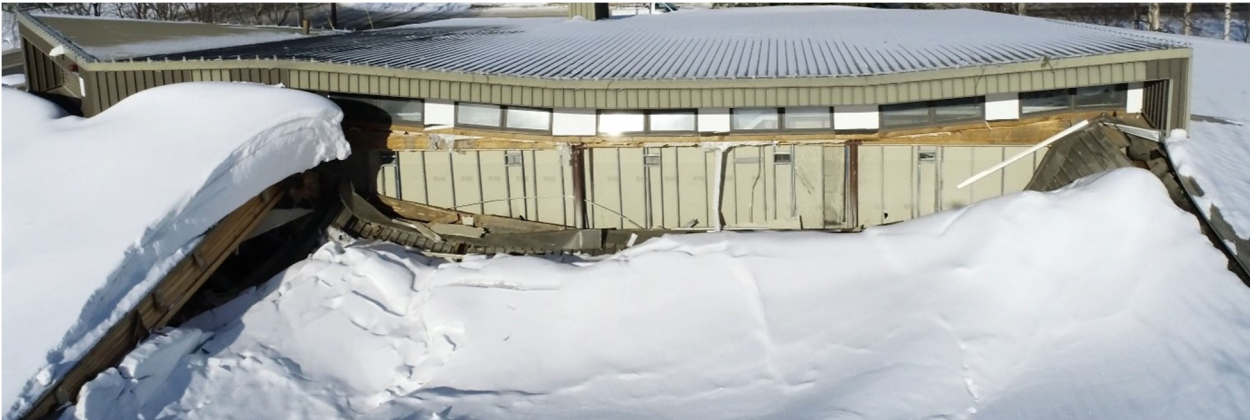
Photo 1: Elevation of Roof Collapse

From the exterior of the building, PND observed that the lower roof over the children’s section had separated from the glu-lam beam supports and collapsed inward (**Photo 1**). PND also noted that the high roof line above the collapsed lower roof was visibly sagging. The source of this sag was not immediately clear from the ground level observation. Video footage obtained via the drone, showed that the glu-lam support beams that supported the low and high roof had been broken along their lengths (**Photo 2**).

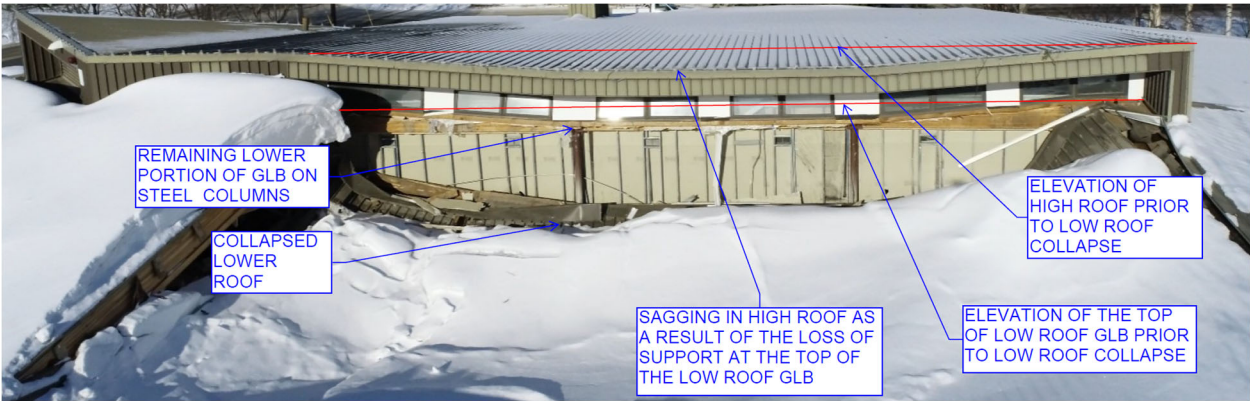
Photo 2: Annotated Elevation of Roof Collapse

The top half to two thirds of the glulam beams had collapsed with the low roof and only the lower portion of the glu-lam beams remained on the steel support columns. The loss of the top portion of the lower glulam beam left the high roof members without support and they settled until they came to rest on the remaining portion of the broken glu-lam beam. **Figure 2** shows a sketch of the structural section as observed from the record drawings which shows how the low and high roofs were supported by the glulam beam prior to the failure. **Figure 3** shows the approximate post-collapse position of the remaining framing.

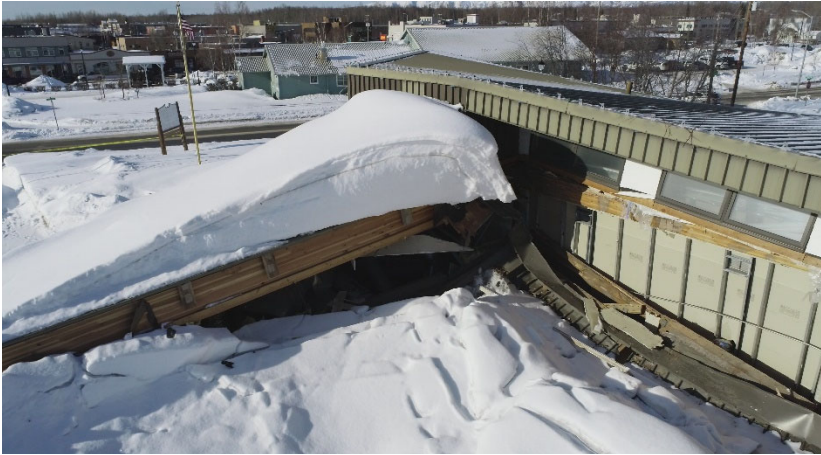
Photo 3: Roof Snow Drift

PND was able to observe the snow drift on the intact portion of the low roof (**Photo 3**). The snow extends from the low roof up to the underside of the high roof overhangs making the snow drift approximately 3 feet deep. The drift appeared to have a very dense lower layer that was topped by two or more layers of softer drifted snow. PND was unable to gain safe access to this drift to take a weight measurement.

PND strongly recommends that the remaining snow drift on the low roof be removed by a qualified contractor prior to the commencement of other work. The removal of these drift will help migrate the potential for additional roof collapse. PND recommends the use of manlifts and/or roof rakes during the snow removal to minimize the personal on the roof as much as possible.

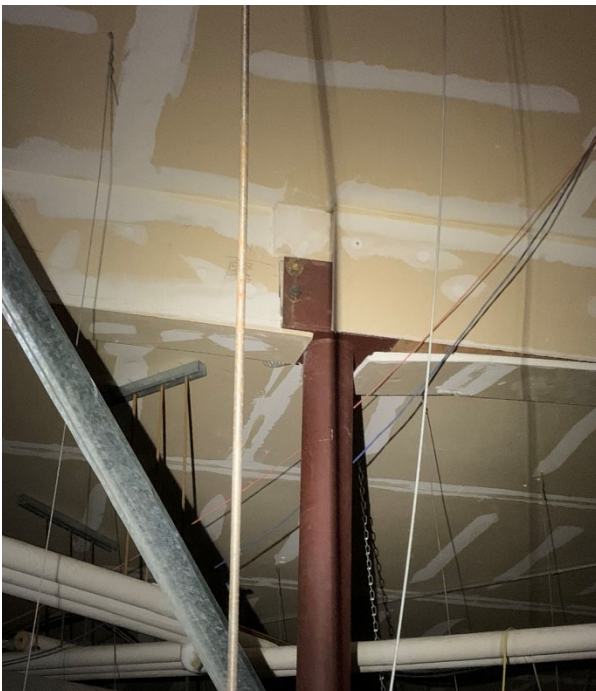
Photo 4: Beam Centered Over Column

were wrapped in gypsum wall board so a full observation of the members and their connections was not possible. However, PND was able to see that the beams were still centered over the interior columns and there was no evidence of large displacements of the roof beams along gridline 2 between grids C & D (**Photo 4**). PND recommends that the gypsum wall board in this area be removed to permit a full investigation of the area before other repairs are completed in the building. Based on the current limited review of this area, the beam and their connections appear to be intact.

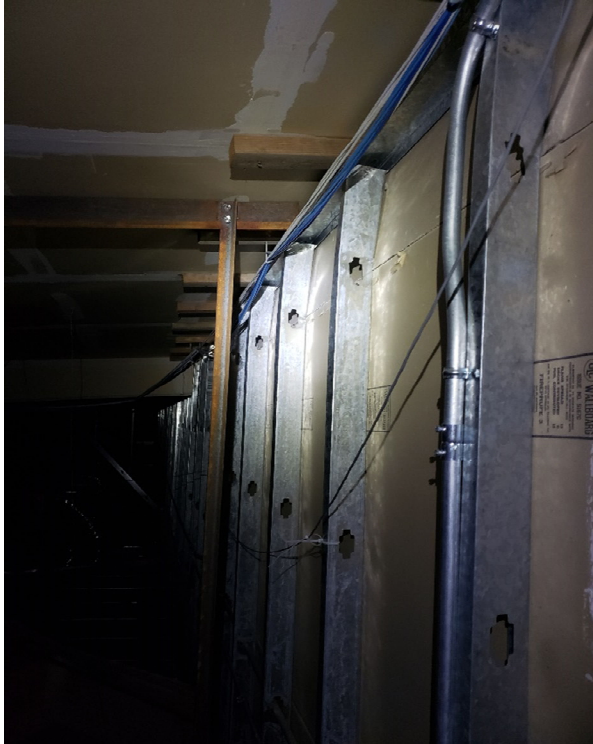
Photo 5: Damaged Soffit

PND was able to observe damage to the backside of the soffit framing over the circulation desk area from above the ceiling grid (**Photo 5**). This damage is the result of the high roof beams losing support along grid line 3 and dropping and crushing the soffits below. Since the soffit framing was firmly attached to the walls and columns below, they could not move downward without being crushed by the high roof (**Photo 6**). Much of this soffit framing is not

accessible for observation at this time. The soffit finishes should be removed in selected areas to allow for complete observation by an engineer before contractors begin clean up and repairs. This additional access will permit the engineer to determine the full extent of the damage and if the soffit needs to be removed to allow safe continued access to the area beneath it.

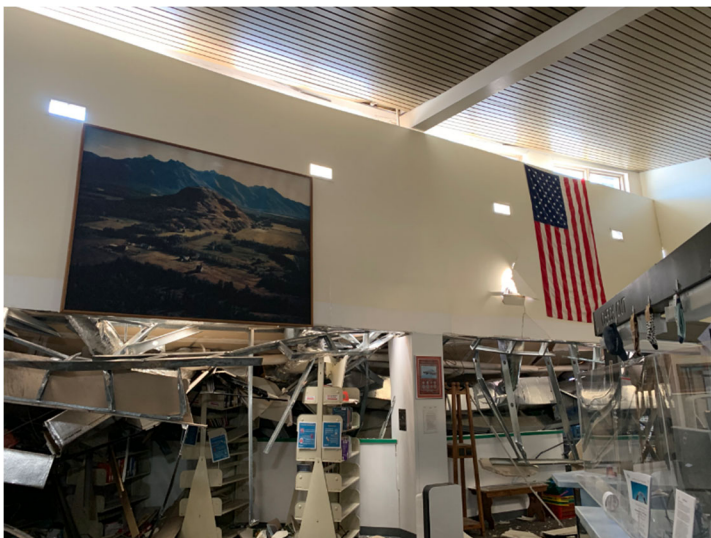
Photo 7: Collapsed Framing and Remaining Soffit

After assessing the high roof, PND shifted the focus to reviewing the area of low roof collapse. The low roof framing came to rest on top of the bookcases. Because the structure is still partially suspended, the collapsed framing is obscured by the remaining soffit that was framed below the roof before the collapse (**Photo 7**). PND was able to see that the top portions of the glulam beams, that broke away from the supports, were still attached to the low roof wood I-joists. The wood I-joists were still sitting within the light gauge steel top flange hangers (**Photo 8**). This observation meshes with the observations from the exterior of the building. PND was able to

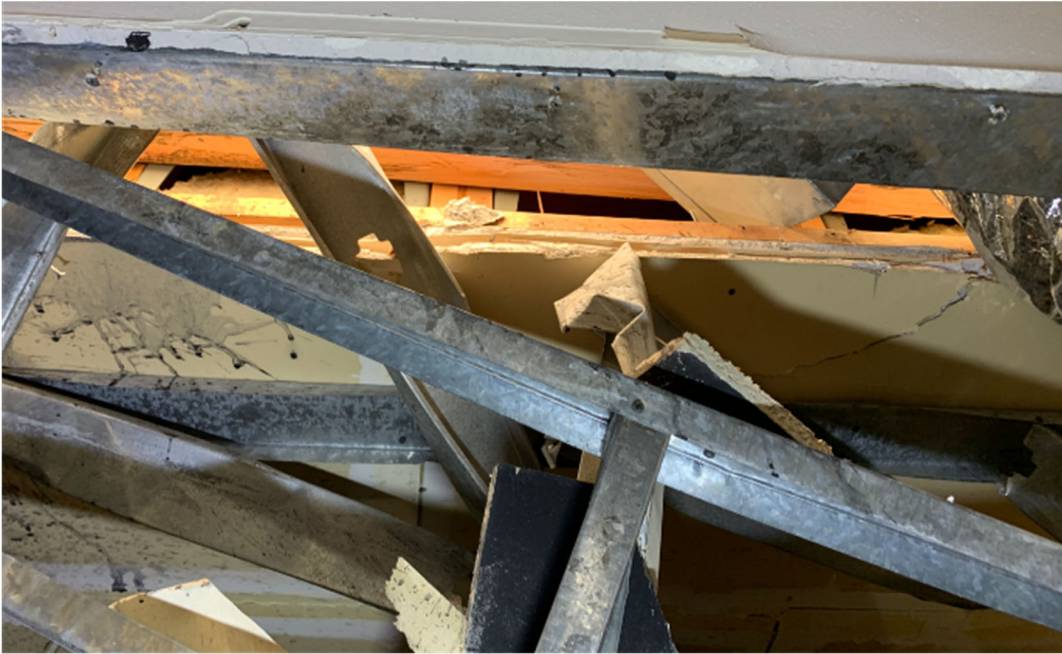
Photo 8: Joist in Top Flange Hangers

observe some water staining on the beams due to past water exposure but PND did not witness any areas of wood rot during the site visit. The complete condition of the round steel support columns and high roof beams could not be ascertained since the elements were still covered with finishes. At least one steel column appeared to be deformed as viewed from the from the drone footage (**Photo 9**).

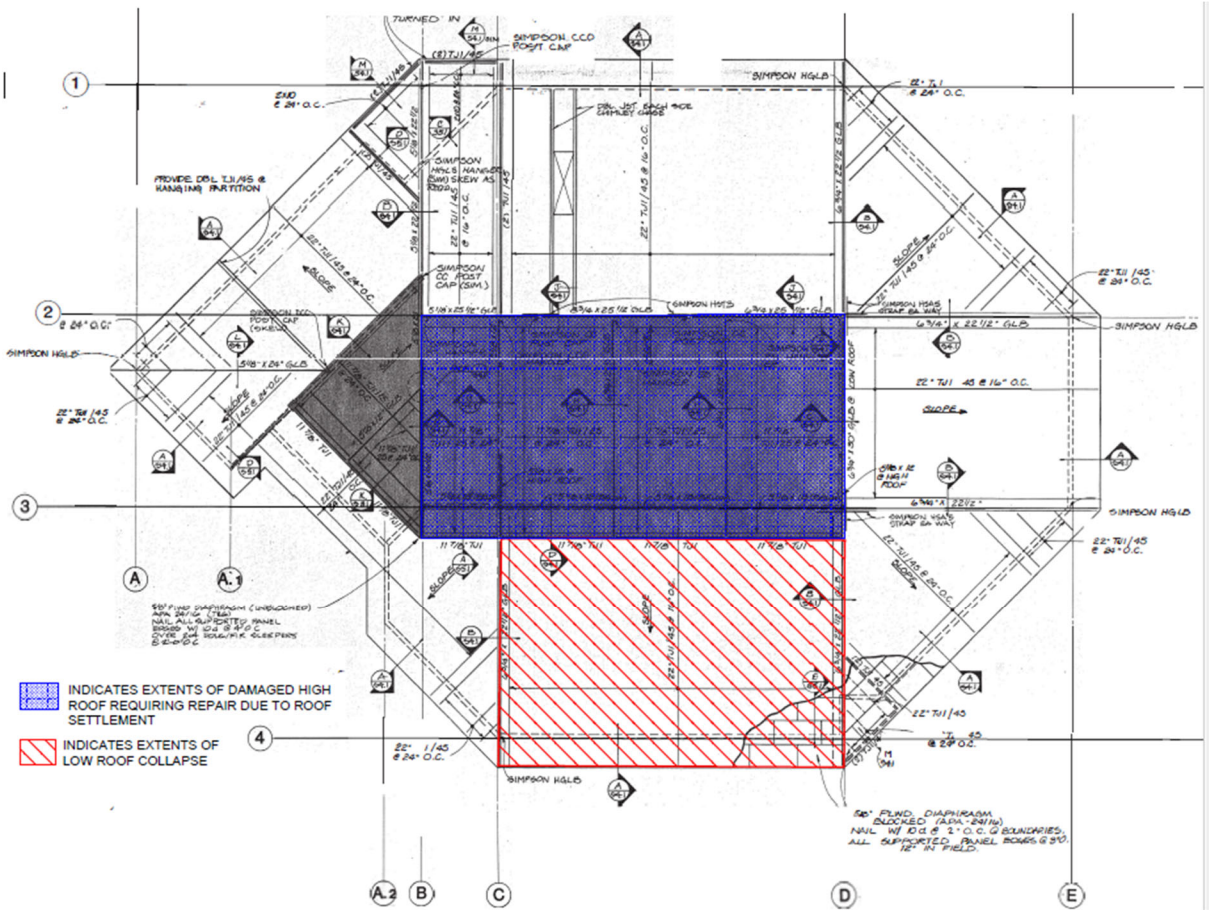
Figure 4: Summary of Observed Damage

Figure 4 shows a roof plan from the building's record drawing with a summary of the damage observed during PND's site visit. This figure only identifies the areas of known damage. It is likely that additional damage will be discovered as building finishes are removed.

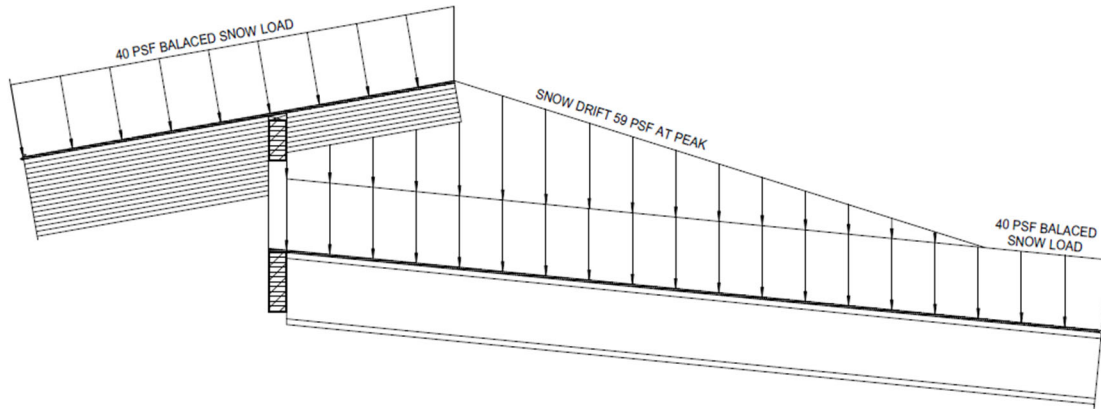
Figure 5: Code Required Snow Drift

additional snow drift loading that would be required by the current building code. Current building code requires the application of a tapered snow drift over the 16.5 feet of low roof starting at the step between the high and low roofs along gridline 3. The snow drift adds 59 psf of snow load in addition to the 40 psf uniform snow drift and the tappers to zero over the 16.5 feet. **Figure 5** shows the snow drift diagram required by the current building codes. This drift loading was not required in the 1980s when the structure was designed. PND could not accurately review the 22" I-joists with the additional snow drift due to the lack of the legacy product data with the manufacturer's member capacities.

With the additional snow drift loading, PND found that the 5-1/8" x 18" glu-lam beams supporting the low roof would be at 120% of their bending capacity. Even though the beams were found to be overstressed in bending, PND does not believe that this was the failure mechanism that led to the low roof collapse. The field observed damage to the beams does not appear to be from a bending failure. The beam failures appear to be the result of torsion on the glu-lam beams. The low roof joists were hung from one side of the glu-lam beam with top flange hangers. PND believes that the one-sided application of the high snow loads may have led to a rotational loading on the beams which exceeded their torsional capacity. Another possibility is that the low roof I-joists broke due to the high snow drift loading and the forces experienced during the collapse pulled the support beam apart. Both of these failure modes would have likely occurred before the glu-lam beams were overstressed in bending. Either of these failure modes would explain the observed longitudinal failures along the lengths of the support beams.
