650 EAST YUKON STREET
PALMER, ALASKA

PHASE I ENVIRONMENTAL SITE ASSESSMENT

FEBRUARY 2022

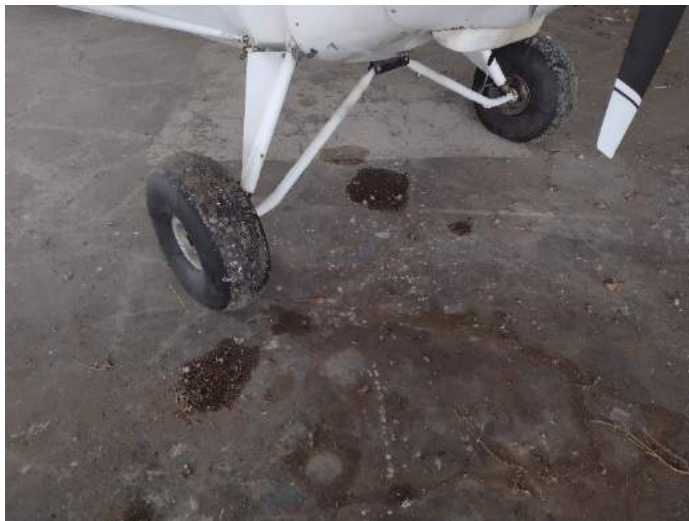
A moderate amount of staining was present on the concrete flooring (Photograph 7 in Appendix A), as well as extensive cracking reportedly related to the former use of the building for storing heavy equipment (Photograph 8 in Appendix A). Cans of oil and solvents were stored on wooden shelving in the northeast portion of the warehouse (Photograph 9 in Appendix A). The annex area contained a 55-gallon drum labeled “oil” that was empty at the time of our site reconnaissance (Photograph 10 in Appendix A), as well as several smaller plastic containers, one of which contained fuel and the rest of which were empty at the time of our site reconnaissance (Photograph 11 in Appendix A). The warehouse area contained several small airplanes which were being stored there (Photograph 12 in Appendix A). The annex contained airplane parts, construction materials, two upright freezers, a lawn mower, and welding gasses (Photograph 13 in Appendix A).

Minor to moderate staining was observed on the concrete floor in several locations within the building. The floor had numerous cracks and deteriorated areas, some of which were in proximity to the stains. It is presumed that the staining is from drips from aircraft or heavy machinery currently or previously stored in the building, or from associated maintenance, and are likely somewhat limited in quantity of contaminants. In addition, although considerably cracked and deteriorated, the concrete floor provides some measure of protection against downward migration of contamination to the subsurface floors. Therefore, it is our opinion that this occurrence is not a considered to be a recognized environmental condition with respect to the subject property. However, it is impossible to rule out the potential that the subsurface soils have been impacted by the releases evidenced by the staining. If it is important to evaluate this potential further, soil borings could be advanced through the concrete floor, and soil samples could be collected and analyzed for the presence of hydrocarbon-related substances.

Photo 7. Staining on Concrete Floor

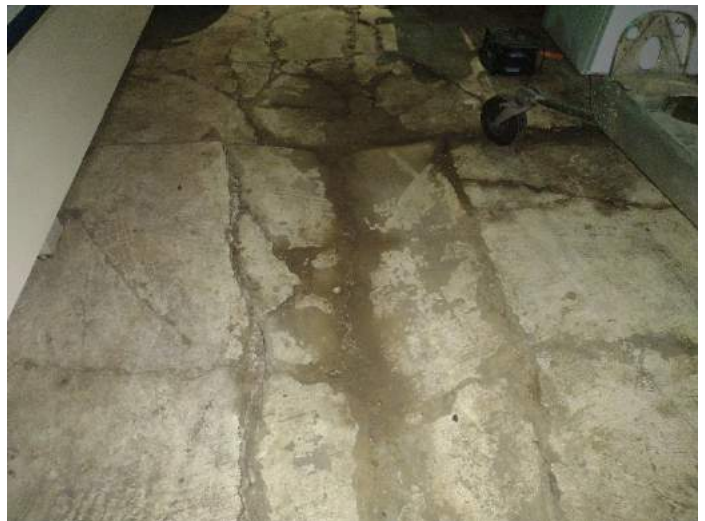
Photo 8. Staining and Cracking on Concrete Floor

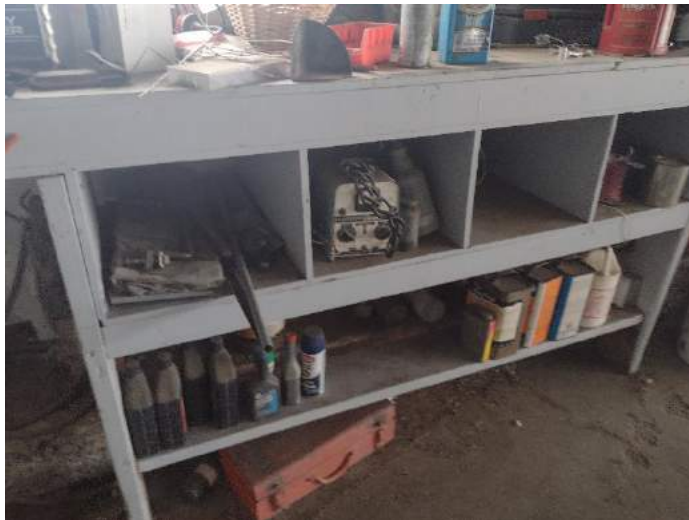
Photo 9. Oil and Chemical Storage on Shelving

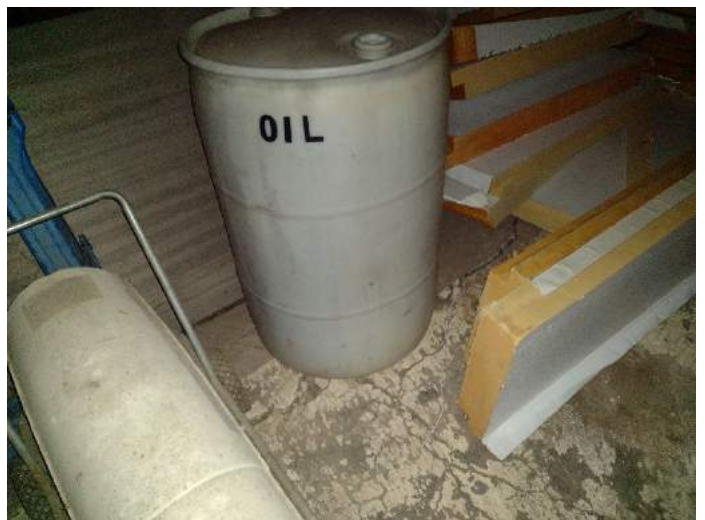
Photo 10. Empty 55-Gallon Drum Labeled "Oil"

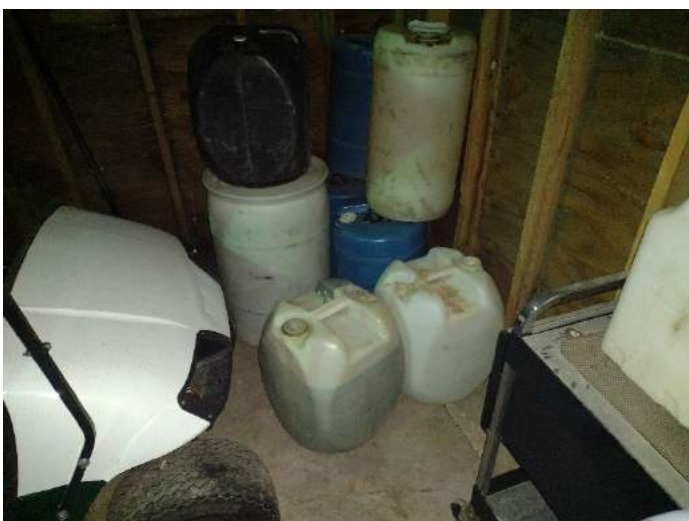
Photo 11. Plastic Fuel Containers (One Full)

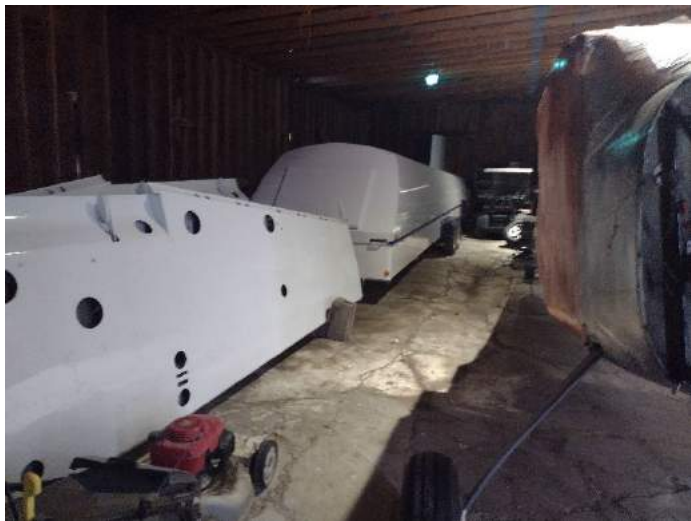
Photo 13. Annex Interior

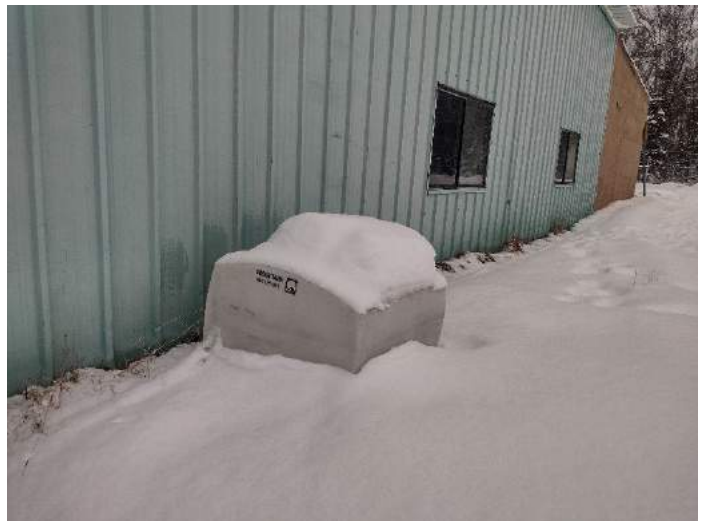
Photo 14. Empty Tank on East Side of Building (Facing North)
