# Palmer Public Library Conditions Survey

# **PALMER PUBLIC LIBRARY ROOF COLLAPSE Structural Observation Report**

**February 28, 2023**

**PND Project Number: 231025**

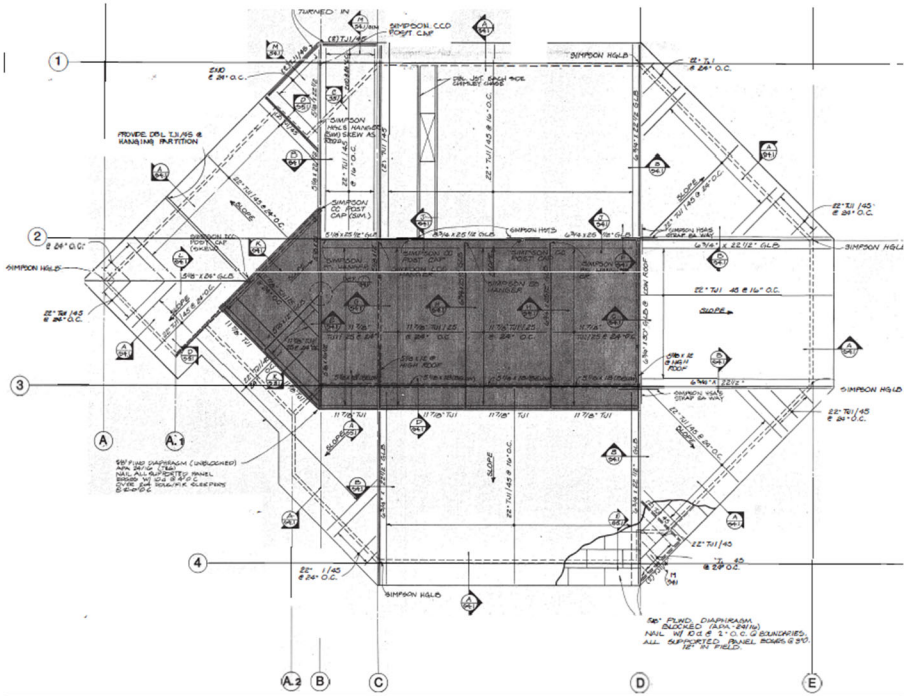
Figure 1: Roof Framing Plan

The record drawings specify that the roof was designed for a uniform roof snow load of 40 pounds per square foot (psf). It is possible that the original library designers may have considered additional snow loading to account for potential snow drifts. Snow drift loads are additional loads applied to the structure in addition to the uniform roof snow load in to account for the extra weight present on the roof in areas
