Palmer Municipal Airport Master Plan Volume 1

City of Palmer
231 West Evergreen Avenue
Palmer, Alaska 99645

HDL ENGINEERING
Consultants
Palmer and Anchorage, Alaska

August, 2016

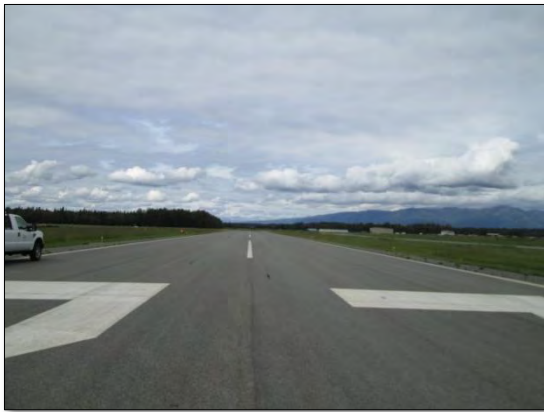
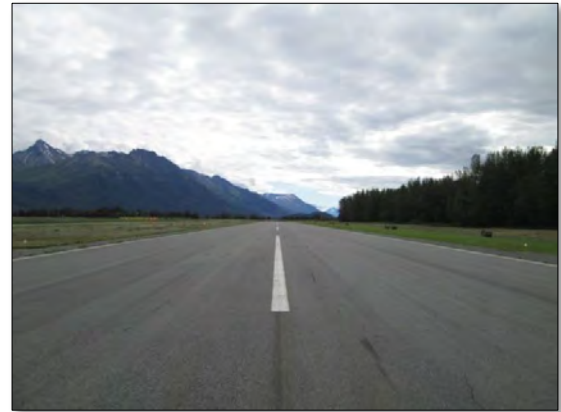
Figure 2-6. View West on Runway 27

Figure 2-7. View East on Runway 9

Runway 9-27, the crosswind runway, is paved, lighted, and measures 3,617 feet by 75 feet (Figures 2-6 and 2-7). Runway 9-27 was rehabilitated in 2007. The runway is classified as B-II and is an instrument runway. In 2007, the structural section depth was increased to 54 inches and pavement depth increased to 3 inches to support B-II aircraft. The 12,500-pound weight restriction (small aircraft) has not been removed. The adjoining Taxiway B will be discussed in *Section 2.5.3 Taxiways*. Taxiway B will not support heavy aircraft.

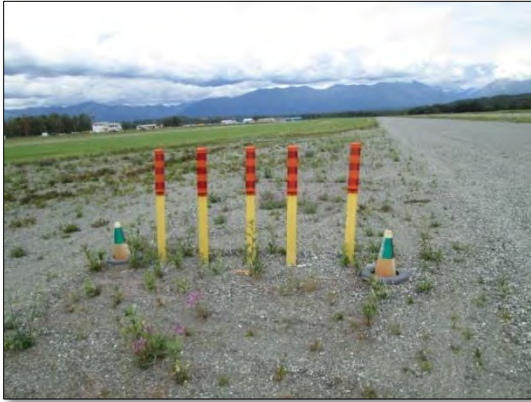
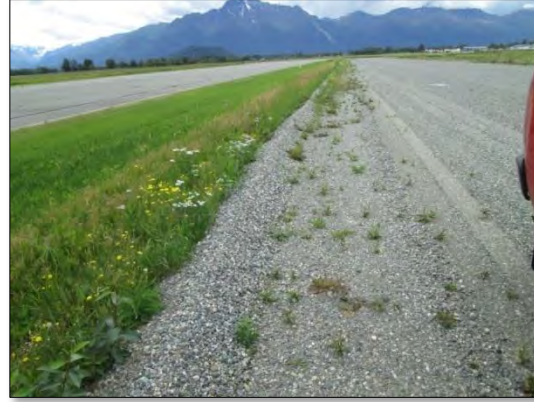
Figure 2-8. Runway 16S-34S Threshold Markers

Figure 2-9. Runway 16S-34S Gravel Berm

Runway 16S-34S, the STOL runway, has a gravel surface and is located adjacent to Runway 16-34. Runway 16S-34S pilots use the same traffic pattern as Runway 16-34 with no simultaneous operations. The runway measures 1,560 feet by 60 feet. This gravel strip is unlit and is used regularly by tundra-tired aircraft and occasionally by ski-equipped aircraft. The threshold is marked with reflectors. Some of the two-color threshold reflectors at the thresholds are reversed and facing the wrong direction (red toward the runway rather than red away from the runway). A gravel berm has been pushed out to the edges of Runway 16S-34S by maintenance operations and exceeds the 3-inch FAA runway safety area surface gradient standard (Figures 2-8 and 2-9).

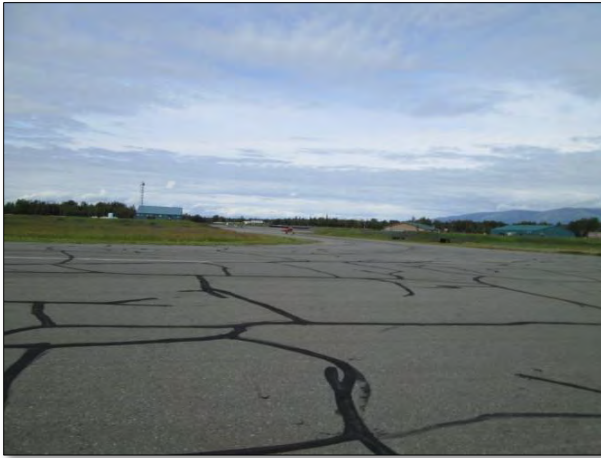
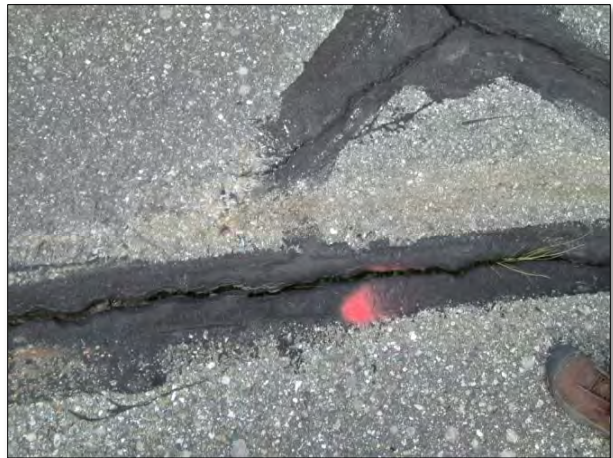
Figure 2-14. Pavement Cracks (Magnitude)

Figure 2-15. Pavement Cracks (Severity)

A Pavement Condition Index (PCI) of less than 70 indicates a need for corrective maintenance or pavement rehabilitation such as patching and crack sealing. Runway 16-34 has an average PCI of 54 and Runway 9-27 has an average PCI of 95. The PCI for the taxiways ranges from 62 to 92. Runway 16-34 is in the poorest condition, particularly in the first 1,000 feet of Runway 16 which has block cracking, raveling, corrugation, and longitudinal and transverse cracking (Figures 2-14 and 2-15). The taxiways and aprons are all in fair to good condition, with some needing corrective or preventative maintenance in order to maximize their useful life. See the Palmer Municipal Airport Pavement Management Plan (HDL, 2013) included in Appendix G for more detailed information.

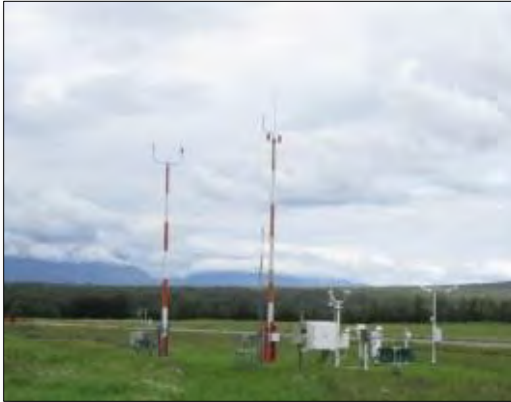
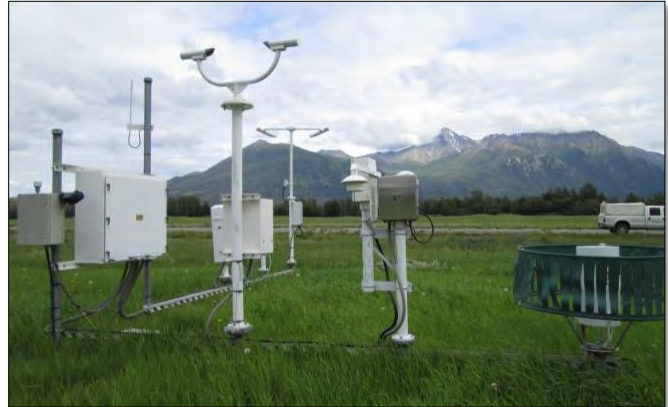
Figure 2-21. ASOS Equipment

Figure 2-22. ASOS Equipment

The airport is equipped with an Automated Surface Observing System (ASOS) located south of the Flight Service Station (FSS) near the center of the airport. The ASOS has a 500-foot buffer around the facility so airport structures do not affect observations. The ASOS program is a joint effort of the National Weather Service (NWS), the FAA, and the Department of Defense (DOD). The ASOS system provides automated weather information to the FSS, pilots via radio frequency and telephone, and the nation's primary surface weather observing network. The ASOS site is leased by the FAA (Figures 2-21 and 2-22).

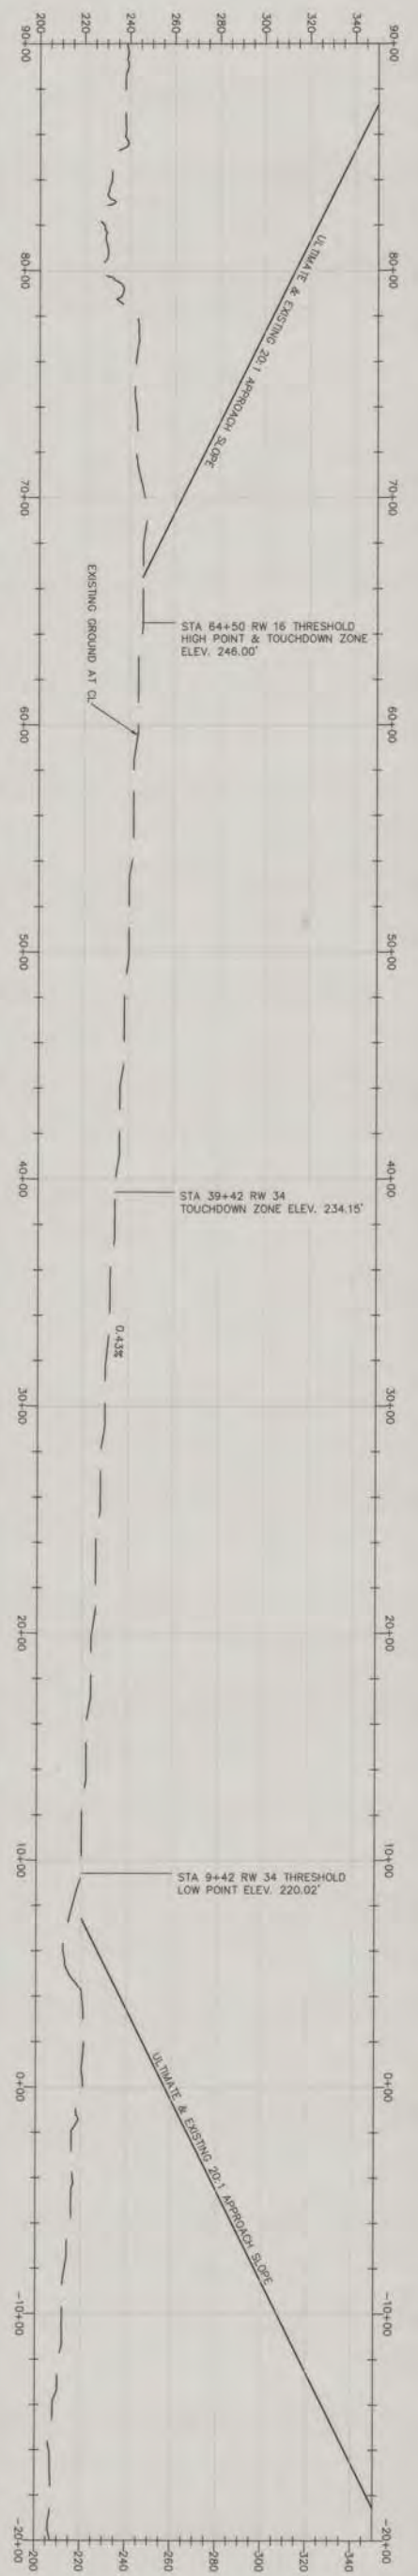
1 RUNWAY 16/34 PROFILE
SCALE: 1"=400'

NOTES:
RW 16 TOUCHDOWN ZONE EFFECTIVE GRADE: 0.41%
RW 34 TOUCHDOWN ZONE EFFECTIVE GRADE: 0.47%
RW 16/34 HAS CLEAR LINE OF SIGHT

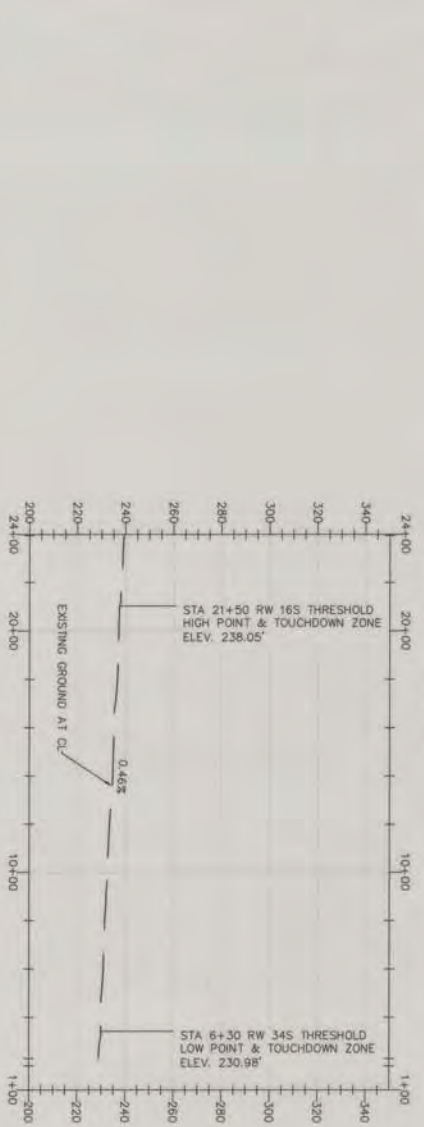
3 RUNWAY 16S/34S PROFILE
SCALE: 1"=400'

NOTES:
RW 16S TOUCHDOWN ZONE EFFECTIVE GRADE: 0.46%
RW 34S TOUCHDOWN ZONE EFFECTIVE GRADE: 0.48%
RW 16S/34S HAS CLEAR LINE OF SIGHT
